# Ash and Martock Nature - Phosphate Survey

Report 4

## The impact of the drought on phosphate levels in the Parrett catchment

Andrew Clegg, August 2022

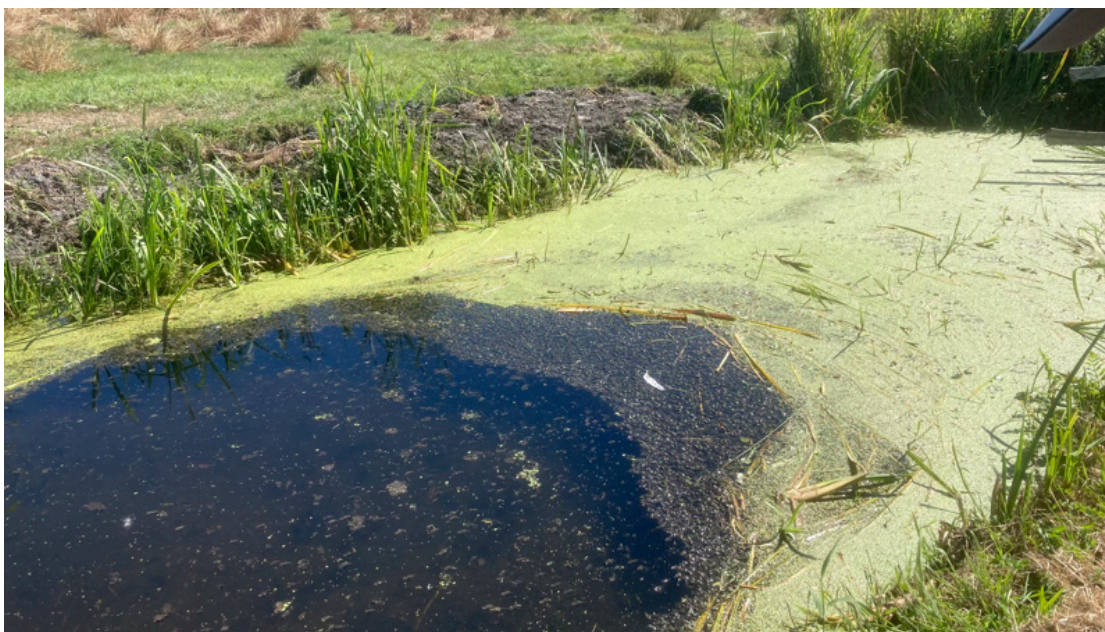
A West Sedgemoor rhyne. To the right, azolla. In the foreground, thousands of water snails inverted, driven to the surface probably by the warm anoxic conditions; this is the way snails 'breathe' but not simultaneously and in such large numbers.

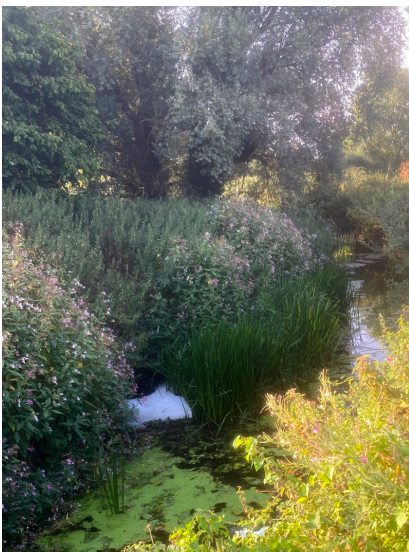
1 The outflow of Martock STW (August 4.5ppm) obscured by a rich growth of balsam, reed and duckweed

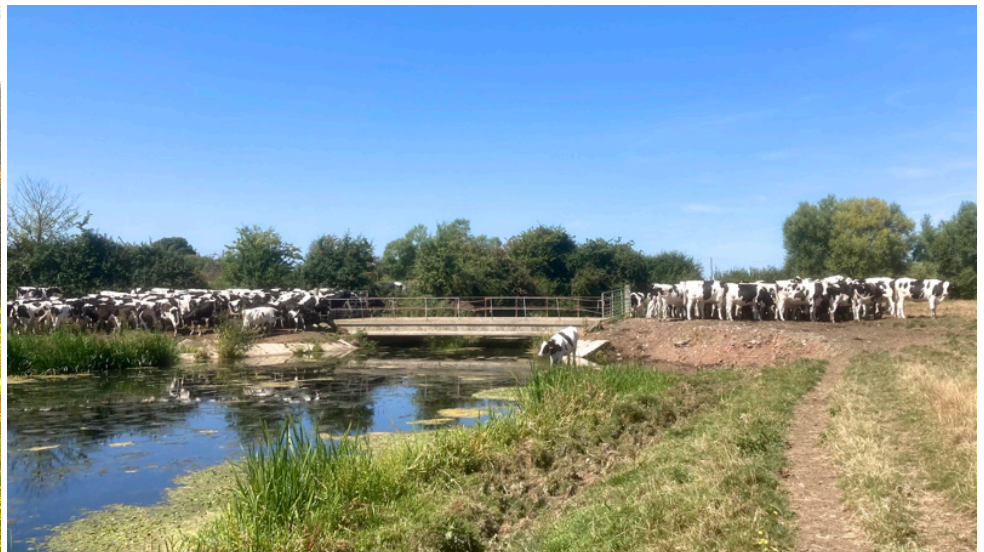
2 Witcombe Bottom Main Drain. 200+ heifers standing stationary in the heat in two tight groups on opposite banks their water supply. (May, 0.05, August, 2.50 ppm). See section 9 below.

Witcombe Bottom Main Drain area was being used for summer grazing of about 250 heifers which had no other water source and extensive poaching was evident at the lower end of the Drain where the testing is usually done. This may be the main origin of the very high level of phosphate in this end of the drain which is in marked contrast to earlier (May) data which showed this Drain to be a significant remover of phosphate.

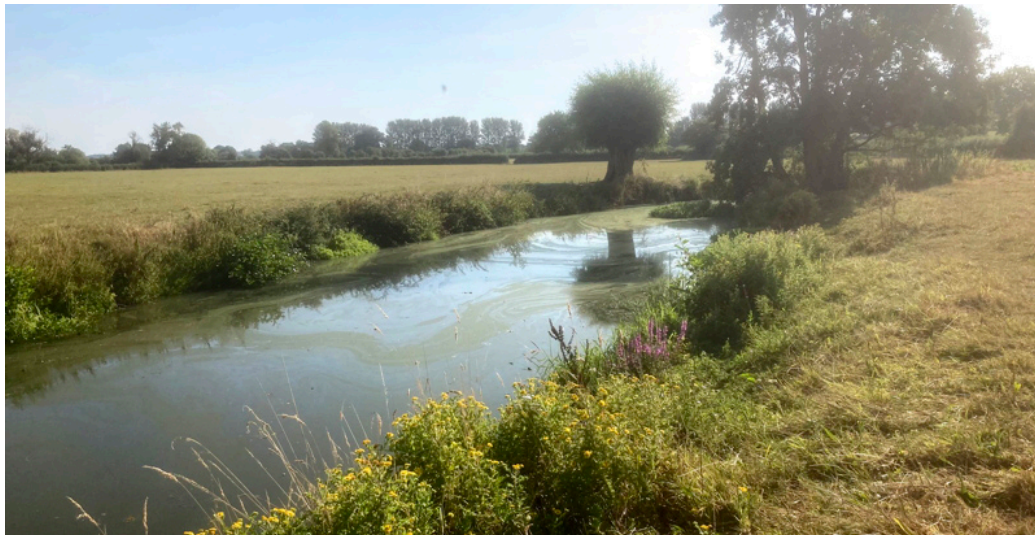
Evidence of blue-green algae in the very slow flowing meandering Parrett just before it enters its artificially straightened channel to the sea.

Significant stretches of the Parrett above Gawbridge, where the flow is slow and naturally meandering, have become covered in a rime of what appears to be mainly blue-green algae.
